# AURIX™ TC35x errata sheet

**Marking/Step: (E)ES-AB, AB**

10528AERRA

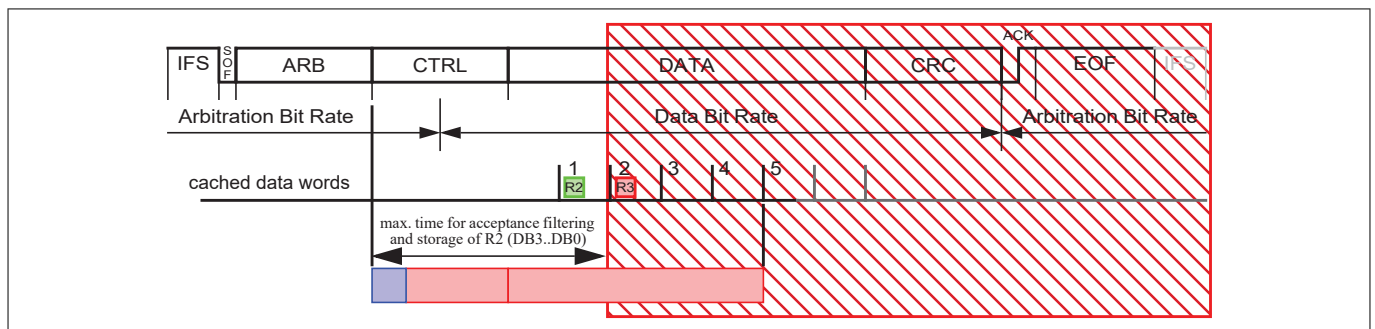
**Figure 5 CAN Frame with DLC > 4**

Under the following conditions a received message will have corrupted data while the received message is signaled as valid to the host.

The figure that follows shows how the available time for acceptance filtering and storage is reduced.

Due to condition 3) the issue only occurs sporadically. Use an end-to-end (E2E) protection (for example, checksum or CRC covering the data field) and add it to all messages in the CAN system, to detect data corruption in received frames.
